CEDAR COMMONS TREE AND SHRUB ASSESSMENT

**41-45 Cedar Street
Dobbs Ferry, NY**

Matt Weibel

May 8, 2020

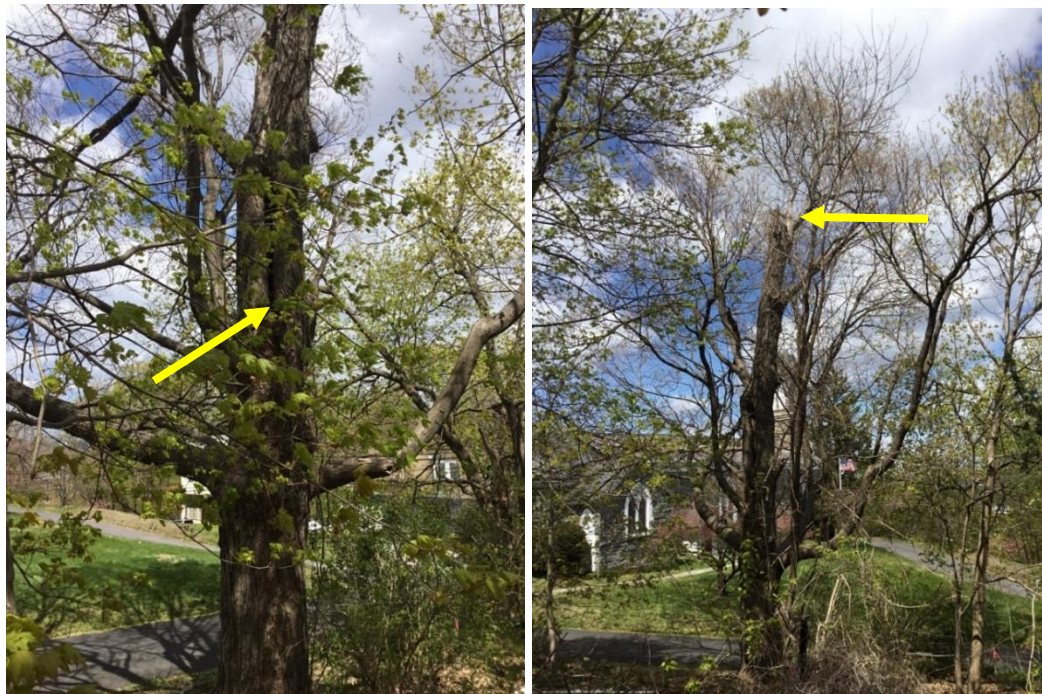
ID #21 is a 32-inch sugar maple tree. It grows approximately three feet from the staked line. The top of tree has been previously broken at approximately 35-40 feet. There is large deadwood in its canopy and large cavity with significant decay from 12-16 feet along its trunk. It does not appear as though the tree has been maintained. The trunk and canopy lean slightly toward the driveway. This tree currently represents an elevated risk to person and property on church property due the level of decay and large deadwood. This tree should be removed prior to construction regardless of whether the project progresses.

Photos taken 4/22/2020 showing ID #21. Note the broken top and large cavity in its trunk (yellow arrows).

| ID | Common Name | DBH | Cond. | Preserve | Defects | Recommendations | Property | Notes |
|---|---|---|---|---|--|---|---|---|
| 21 | Sugar maple | 32 | Poor | No | Prior broken top. Large deadwood. Cavity with significant decay from 12 to 16 feet. Tree does not appear to have been maintained | Remove | Church | Approximately 3 feet from staked property line. Significant impacts to root zone from proposed excavation. |

The large sugar maple (#21) is the only tree species on church property that is not invasive. It has significant structural concerns and is in poor condition. If the tree is not removed prior to construction, excavation will remove a large portion of its critical root zone and increase its likelihood of failure.
