**Date:** June 8th, 2020

**Site Visit Date:** May 29th, 2020

**Subject: Structural Evaluation-Retaining wall/Masonry Work.**  
111 Bellair Drive  
Dobbs Ferry, NY 10522

## **ENGINEERING REPORT**

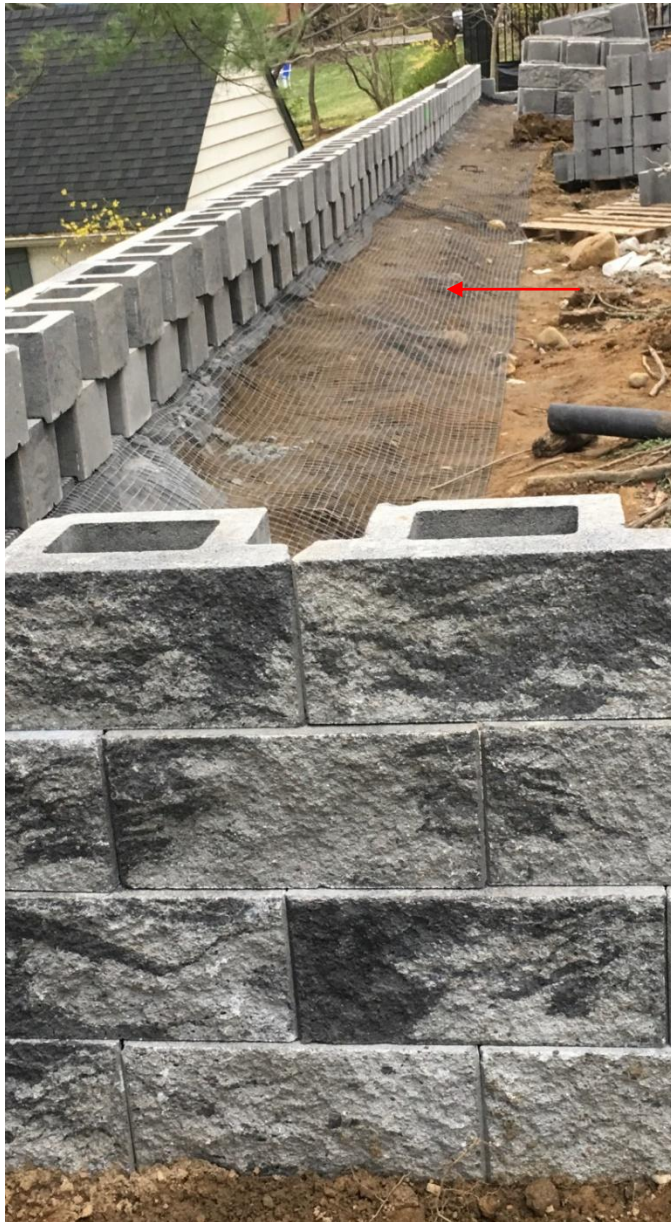
View of wall during construction, note Geogrid Reinforcement being properly installed. This geogrid mat provides lateral reinforcement for the wall, and is specified by the manufacturer. Photo supplied by homeowner, taken during construction.

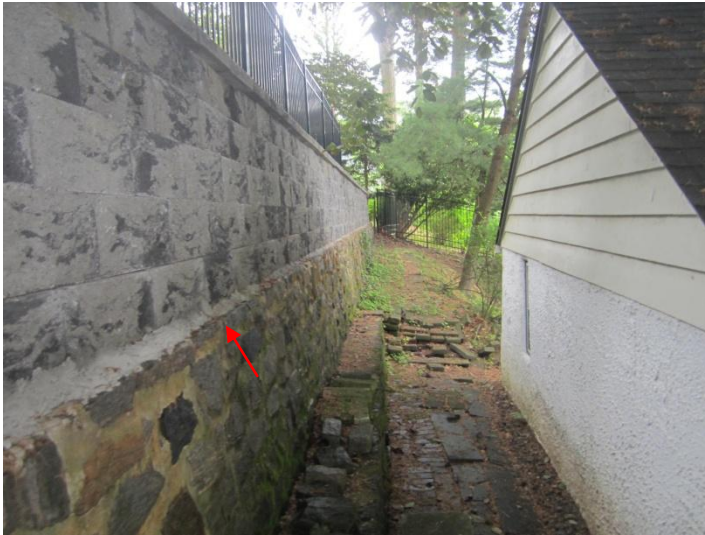
View of retaining wall looking to the South. Wall was found to be structurally sound.

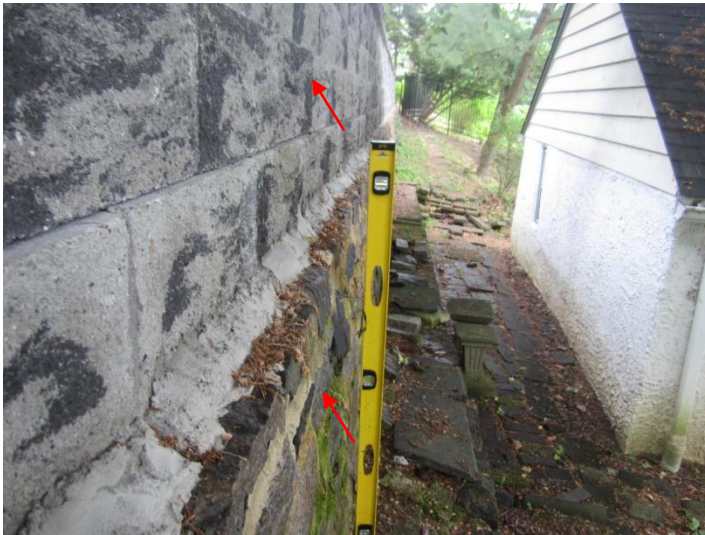
View of retaining wall looking to the South. Both upper new wall and lower original wall are properly installed with proper inward batter angle.

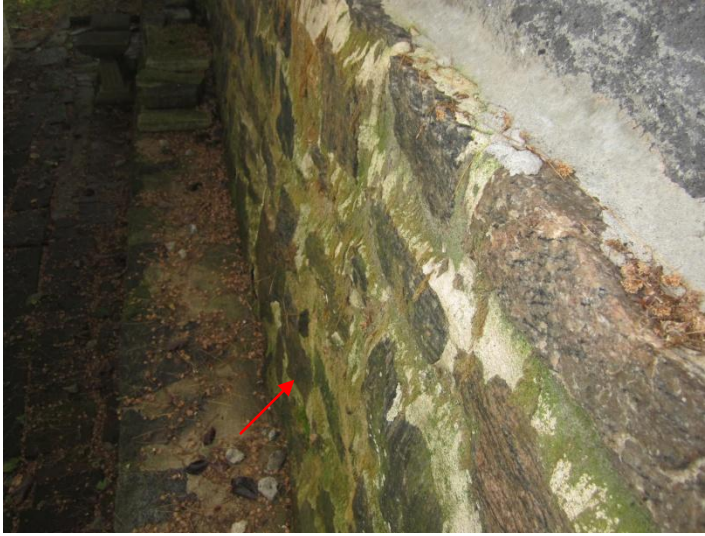
Stone wall at base was found to be sound and free of major deformation.

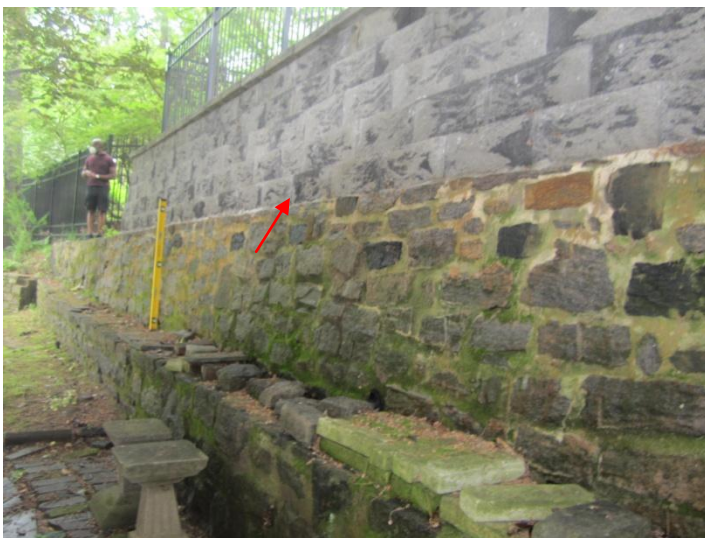
Walls are constructed independant of each other.

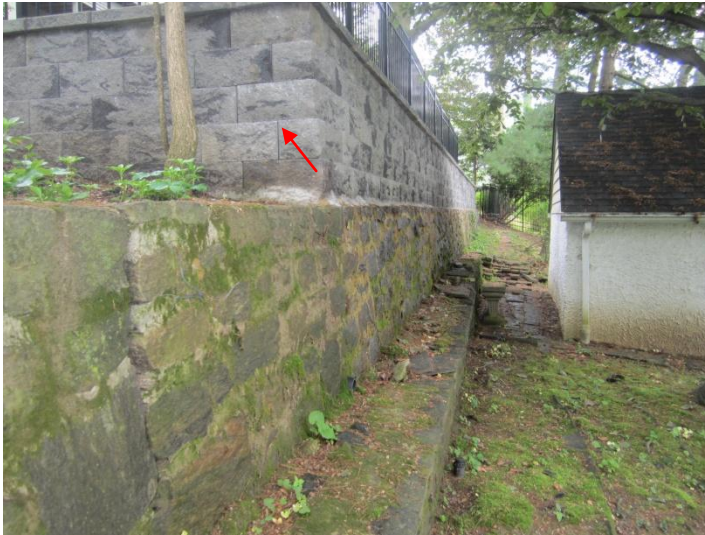
Walls are independent, and has proper return.

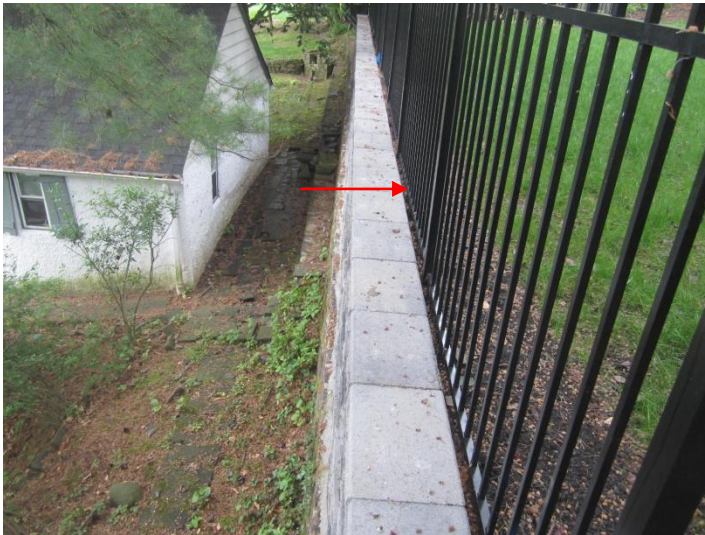
Railing is install properly and found to be sound and rigid.

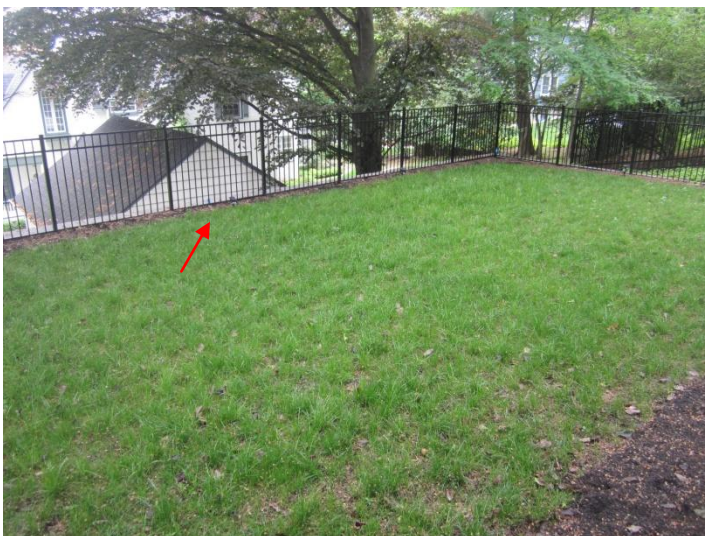
Rear yard is properly pitched, and there is no visible soil erosion or movement.

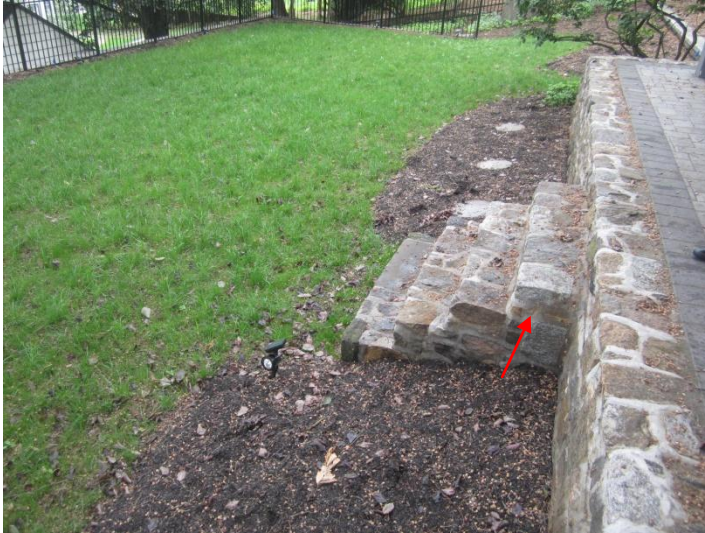
Patio steps need hand rail.

In conclusion, the retaining wall, patio, and drainage were **found to be sound condition** with no evidences of distress at this time. Since this evaluation is a snapshot of the conditions at this moment in time, it is recommended that the conditions be evaluated on an annual basis. This is prudent for all newer retaining walls. Proper handrails and guard rails are needed for the elevated patio which is adjacent to the house.

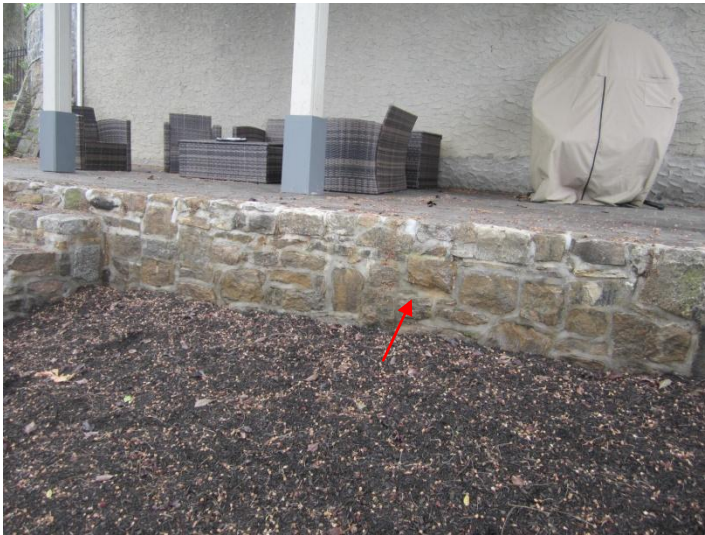
Patio retaining wall is sound.

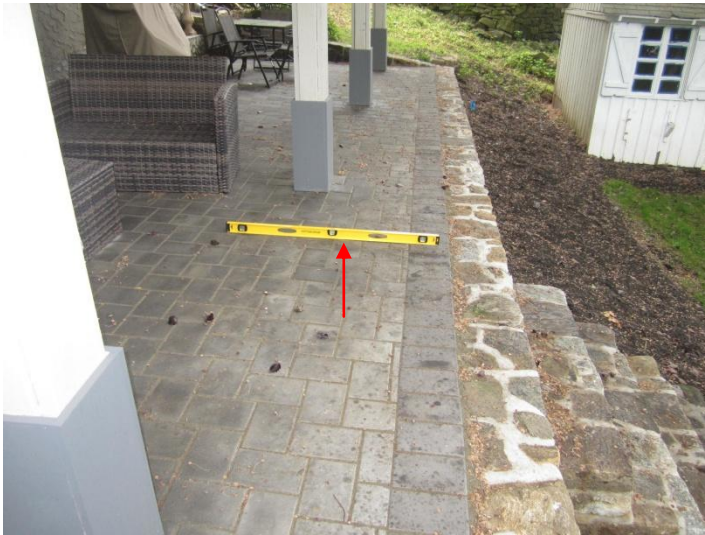
Patio has proper pitch.

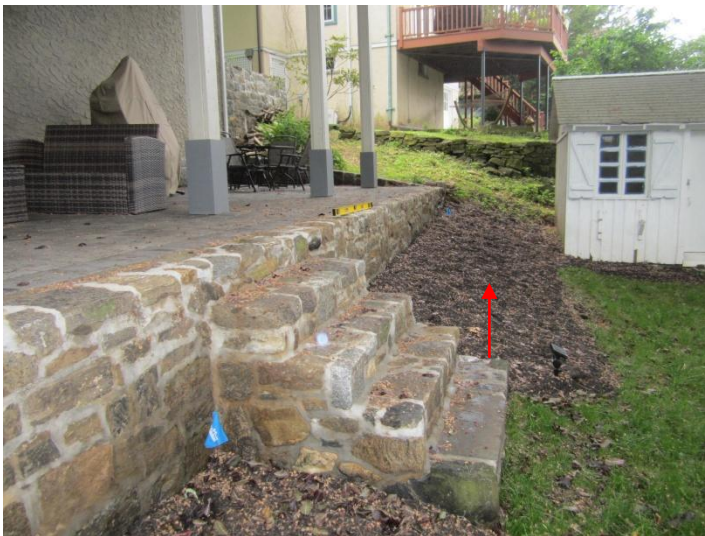
Drainage is good in and around the patio.
