Tree Evaluation Report

Winiarski Residence
63 Livingston Avenue
Dobbs Ferry, NY 10522

October 5, 2022

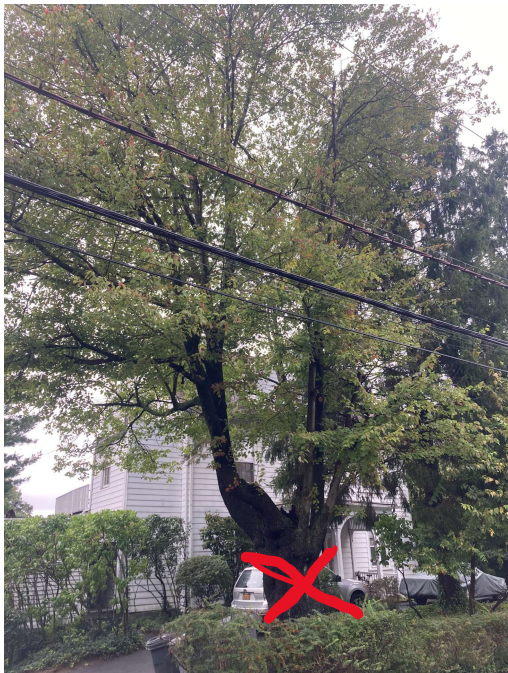
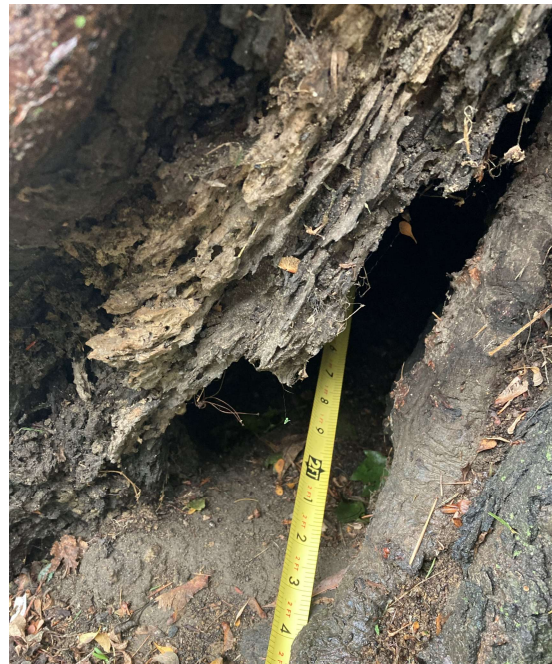
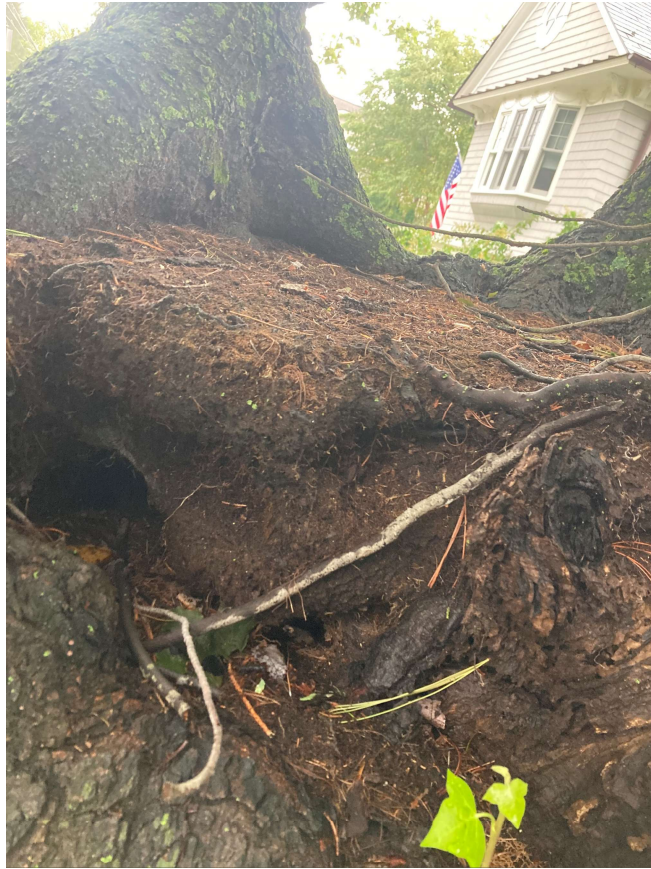
CONDITION: HAZARD - The Red Maple located at the front left of property has previous limb failure in the trunk region 8 feet above grade. This same region has decay and insect infestation. Numerous branches growing are secondary epicormic off shoots as a result of previous limb failure and are not structurally beneficial. The lower root flare and trunk of the tree are severely decayed and hollow. Tape measure was inserted approximately 24 inches into cavity. Tree is structurally unstable and subject to failure.

ARBORIST RECOMMENDATION: Expedited Removal of Tree is recommended

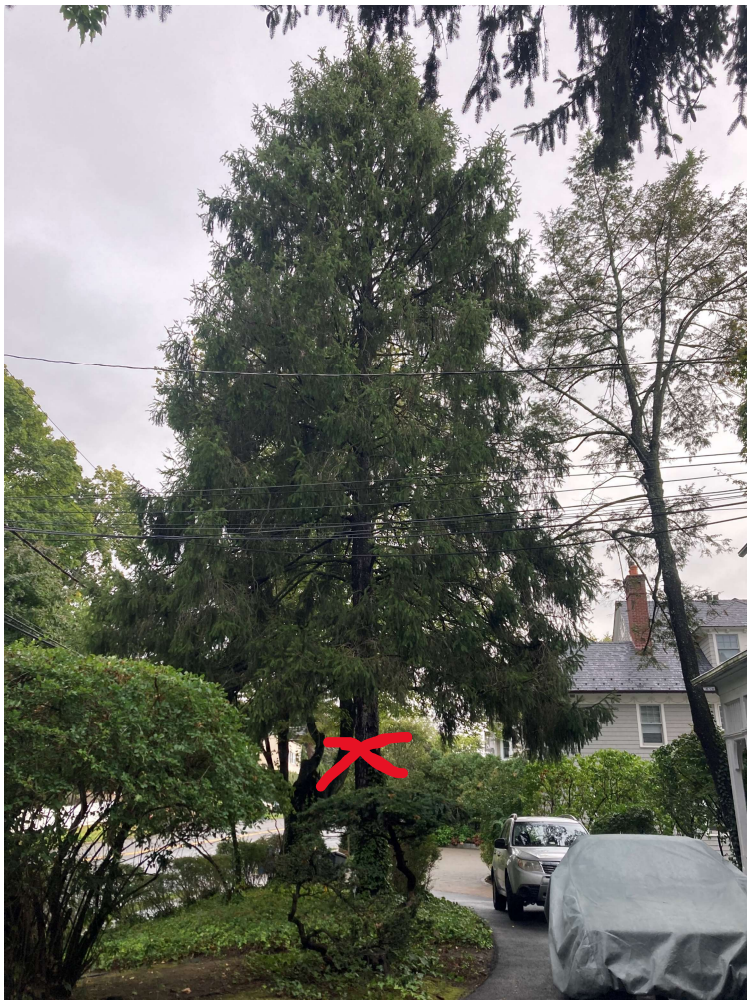
CONDITION: GOOD - The Norway Spruce located at the front center of the property is between the sidewalk and circular driveway. Tree is typical in growth pattern and shows little signs of storm damage and or insect damage. Tree is located 4'-0" from existing blacktop driveway with limited roots protruding under the driveway, as a result the tree will be directly in the area of proposed driveway widening. As a result, there is no possibility for the tree to remain and not severing ALL of the anchor roots on 50% of the root zone. Refer to architectural plans for limits of construction.

ARBORIST RECOMMENDATION: Removal due to Construction

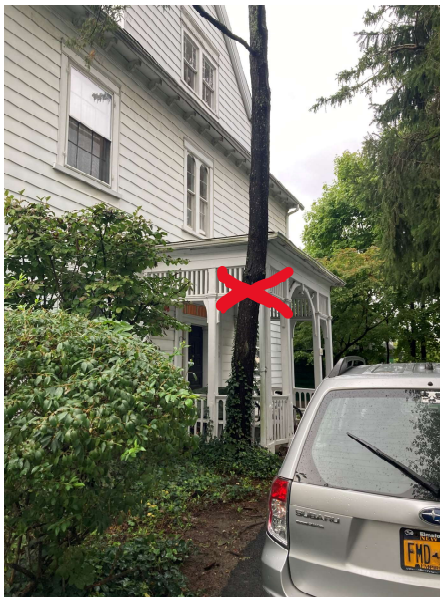
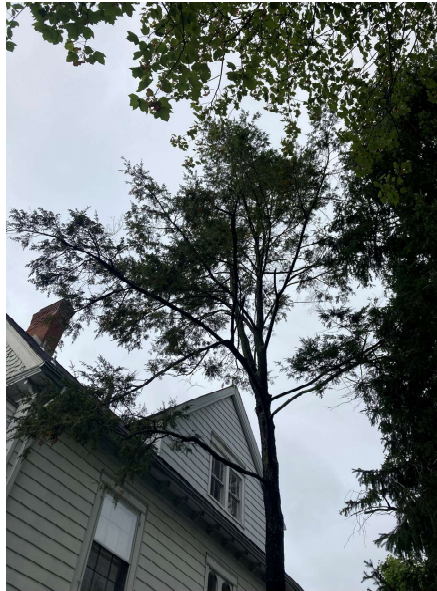
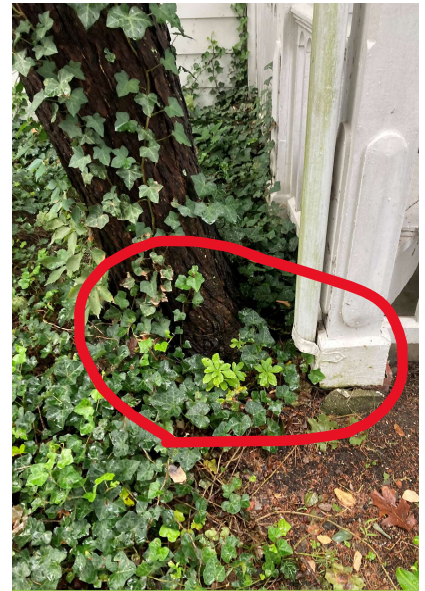
CONDITION: FAIR – The Hemlock to the left of the front entrance is tall and skinny with a heavy crown at the top. This Lollipop” trimming has left the tree top heavy and subject to high wind damage as a result of wind throw. The tree is currently protected by the residence and adjacent Spruce from winds, but removing the Spruce and leaving the Hemlock would suscept the tree to full brunt force wind loading and snapping or toppling can occur.. The crown structure is over reaching the residence, and removing this leader would leave the tree weighted towards the adjacent neighbor’s house. The flare of the tree is approximately 1 foot away from a support pad for the front porch, the concrete blocks have heaves and shifted as a result of the tree roots.

ARBORIST RECOMMENDATION: Removal recommended.

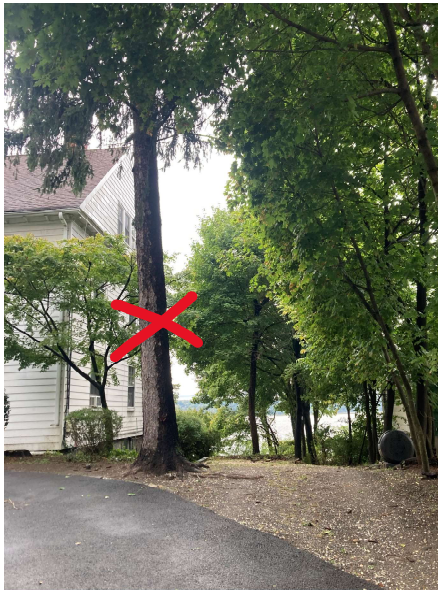
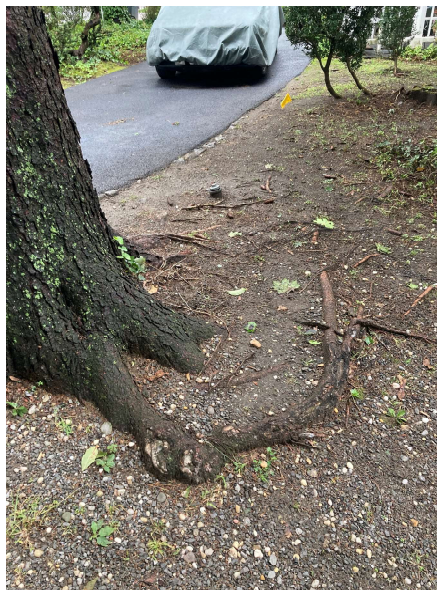
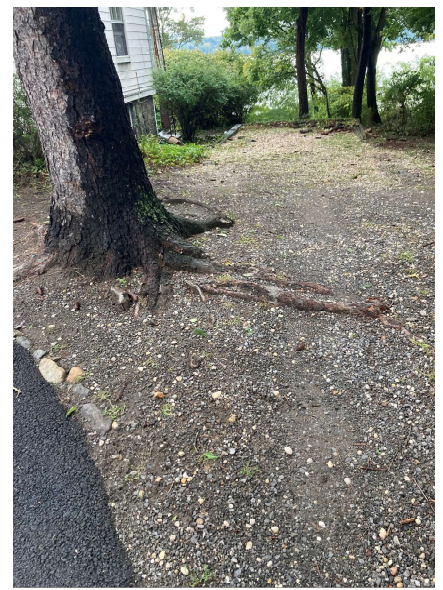
CONDITION: FAIR – The Spruce tree located at the right front of the residence is within the proposed construction zone for a proposed driveway. The current area is utilized as a parking area and as a result the majority of the roots have been compacted and impacted by vehicular traffic. The grading and installation of proposed driveway will sever the 80% root zone and destabilize the tree. Overall health of tree will continue to decline as roots are impacted. There is a current buried fuel oil tank within the proximity of this tree, and should owners consider removal, there would also be no means of supporting the tree. Tree location does not lend itself to any current arboricultural techniques to prevent severe root zone damage.

ARBORIST RECOMMENDATION: Removal recommended.

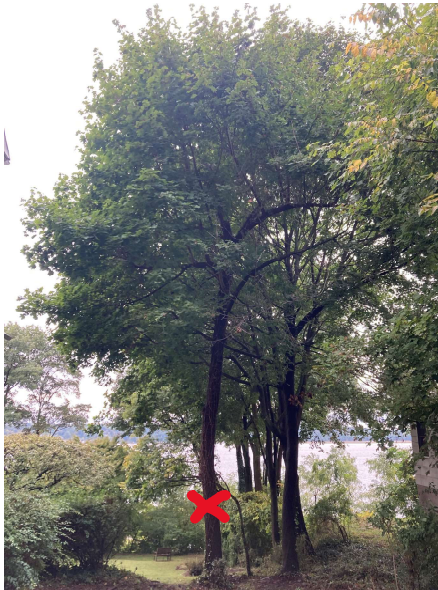
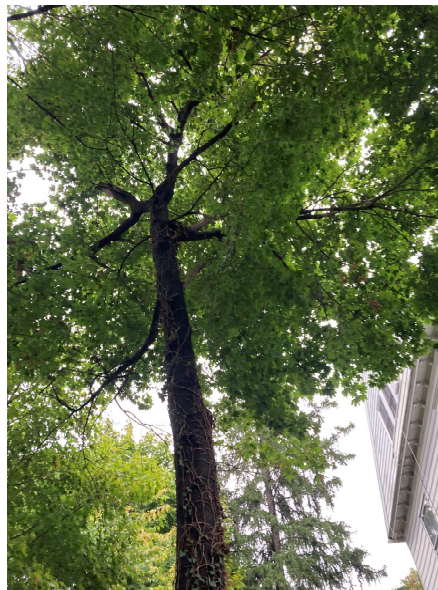
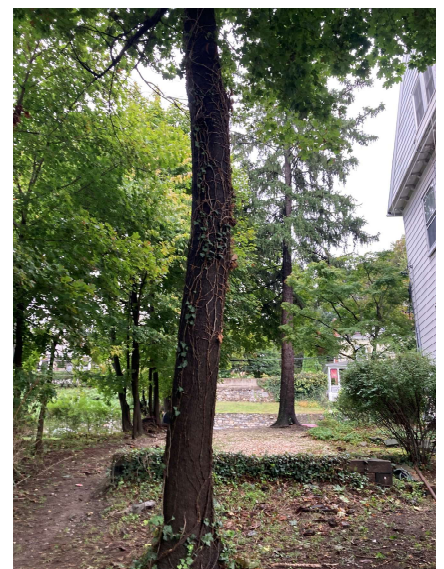
CONDITION: GOOD – The Norway Maple at the rear right side of the house is in good condition. The tree is in the area of proposed driveway expansion and as a result the trunk and roots are in direct conflict and will be completely impacted. The tree is a nonnative invasive species and removing it is considered proper arboricultural practice

ARBORIST RECOMMENDATION: Removal recommended.

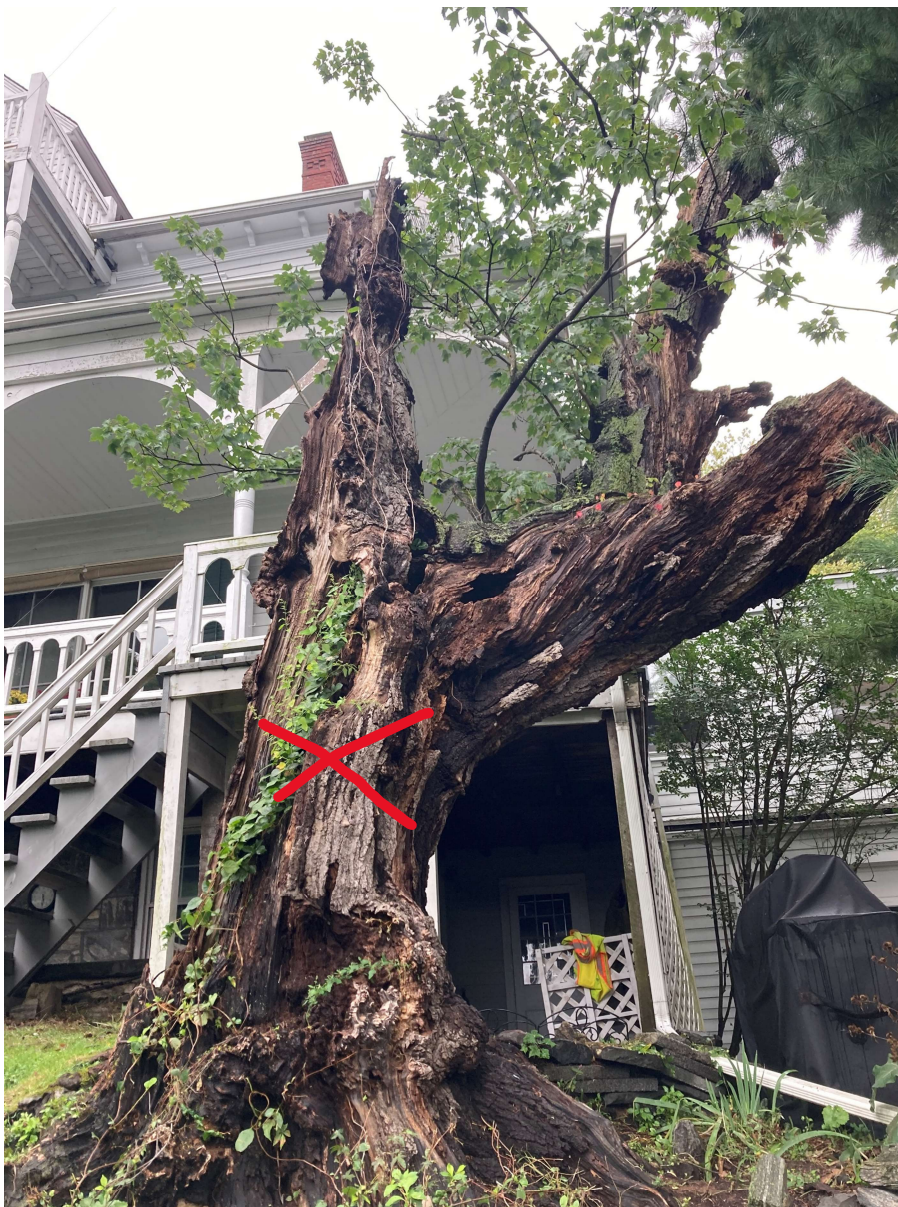
CONDITION: HAZARD – The remnants of a Red Maple at the rear left corner of the property are present. The trunk is in a severe state of decay and rot. Severe insect and wood boring infestation visible. Tree appears to have snapped and / removed many years ago. Remnants are a severe risk and failure is imminent

ARBORIST RECOMMENDATION: Expedited Removal of Tree is recommended
