Village of Dobbs Ferry

RE: 111 Bellair Drive  
Request for Tree Removal

Copper Beech 55" DBH  
Location: South/West

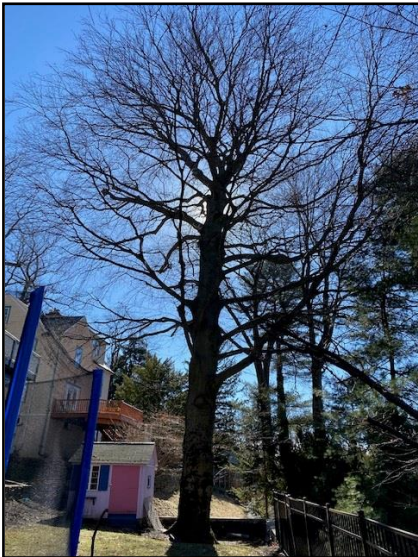
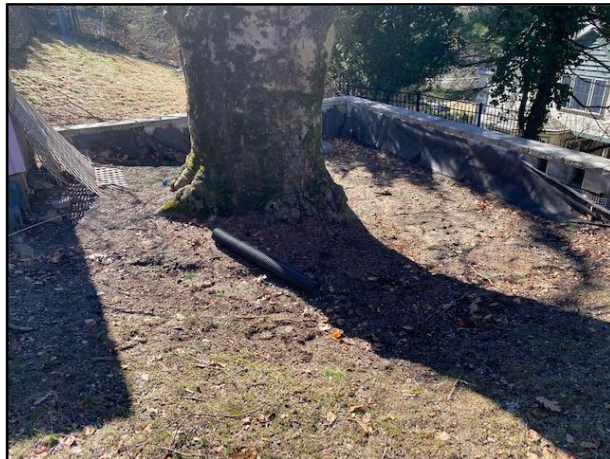
ROOT FLARE- No visible defects observed.

SOIL PROFILE- Approximately 6ft around this tree, organic material was previously installed to amend soil profile to help enhance root zone and reduce compaction.

MAIN TRUNK- No visible defects observed.

CROWN- Full balanced crown, small dead branches observed 2-3" in diameter. Minimal crossing and rubbing scaffold limbs under 10" in diameter, typical of this species growth habit.

In my professional opinion this tree appears vigorous and in good condition per my visual ground inspection of this mature tree.
