Matthew Cordone Architect PLLC

March 14, 2023

Re: 29 Osceola Avenue – Percolation Test

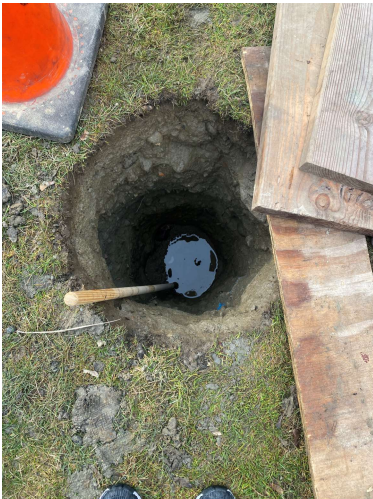
Percolation test initial conditions (fully saturated)

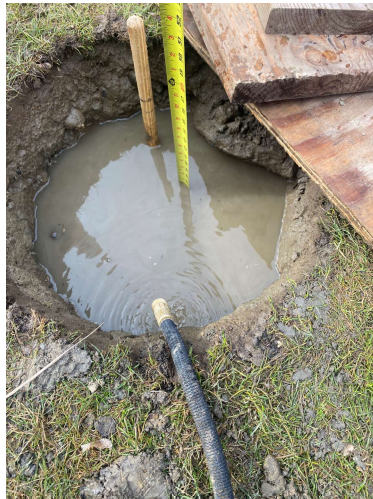
Filling hole with water

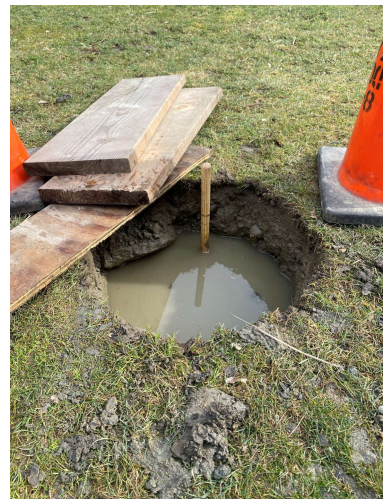
Start of timed percolation test.

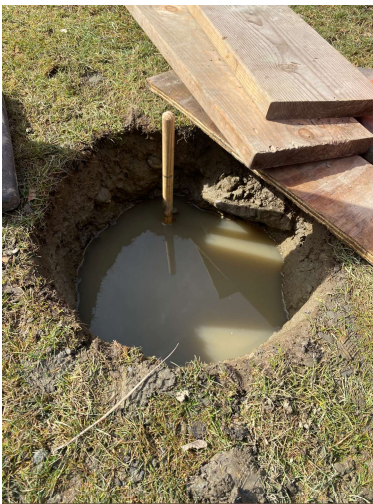
End of timed percolation test.
