VILLAGE OF DOBBS FERRY

Permit Application

Application Number AT2023-0033

Arborist Letter to Village of Dobbs Ferry,

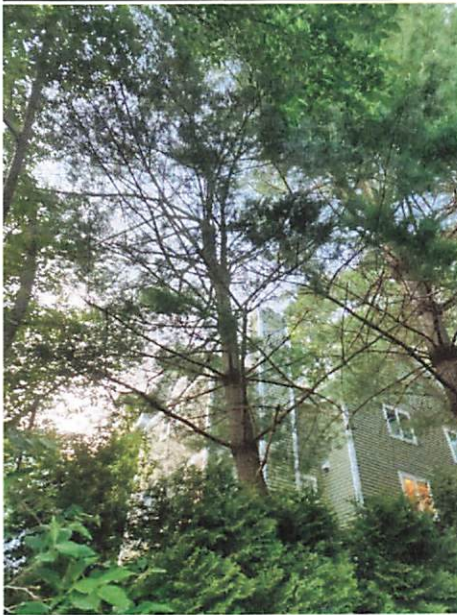
1) Eastern White Pine (1 of 7)

This pine tree has an exposed **ROOT FLAIR**, on the front side but the soil beneath has been excavated and exposed. The exposure makes the **CRITICAL ROOT ZONE (CRZ)** susceptible to temperature extremes. The back end has no **ROOT FLAIR** because it is buried and slowly suffocating the tree since trunks were meant to be above ground for a reason. The tree has suffered a major wound, the central leader has broken off. As I mentioned earlier, the White Pines are weak wooded and suffered mechanical damage due to severe weather. It may have been ice, snow or wind? The subsequent leader that will emerge will only drain the main trunk of vital food and nutrients. The tree has a crack in it's trunk close to the base. The crack may have been caused by moving ground moving slowly underneath the roots. The excavated soil, noted in supplement, at the tree's base may be proof of soil migration. The long-term prognosis of a healthy and speedy recover I not good, so I recommend removal of tree because I consider this a **HAZARD** tree. The top has recently broken off, possibly more tomorrow.

Pine with mechanical damage

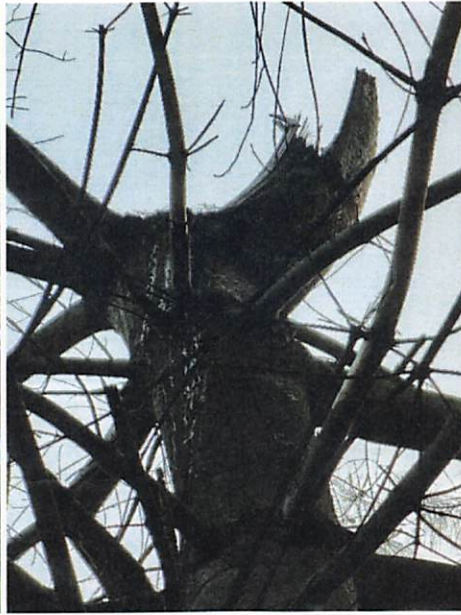
Close-up of recent damage

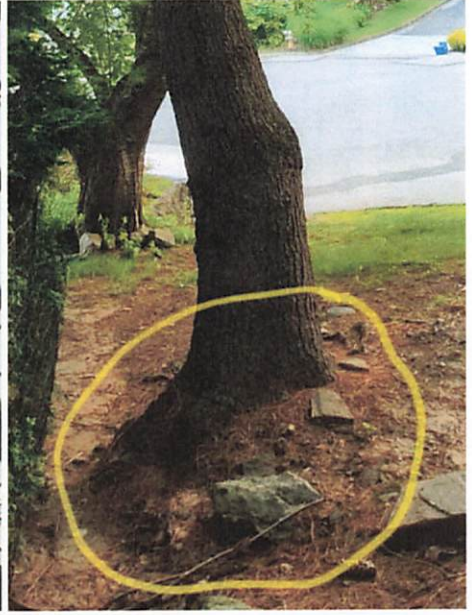
Exposed Critical Root Zone

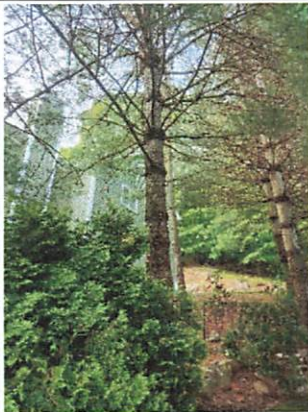
Eastern White Pine (2 of 7)

This pine tree has no exposed **ROOT FLAIR**, growing along a slope. This means that the **CRZ** is buried and slowly suffocating the tree. The tree may have lost it's leader, at some point, because new stems emerged to take on the role for leadership position. Sometimes these stems grow in an unsafe manner and are called **CODOMINANT STEMS**, which are two or more main stems that emerge from the same location on the main trunk. Though such stems may look fine to the casual observer, they may be dangerous. The **CODOMINANT STEMS** form a "V" **UNION** which is more likely to fail than a "U" **UNION**. Stems with a "V" **UNION** compress bark between them as they grow, leaving little physical connection. The tree is near the house and has a **MODERATE LEAN** toward the house. I would categorize this tree as a **RISK** with five **CODOMINANT STEMS** and therefore recommend its removal.

Codominant stems

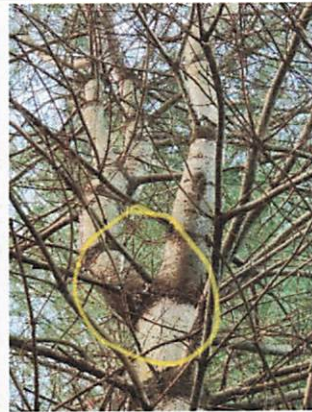
Close-up w visible cankers

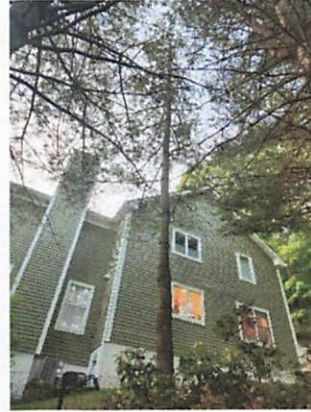
Not much left of this tree

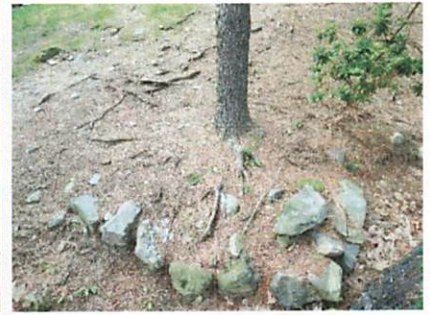
Exposed roots and impeding rocks

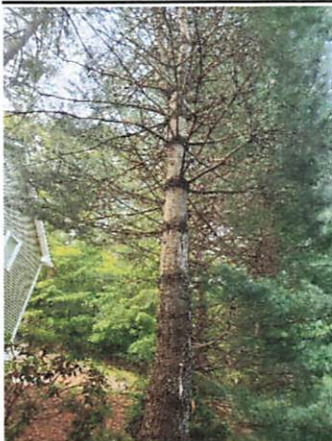
Eastern White Pine (4 of 7)

This pine has several issues. The first is that the tree was planted atop a 2 ½' retaining wall with approximately 3' of bed which does not leave much room to grow any anchoring roots. The back side has no exposed root flair, compromising the **CRZ**. Soil has eroded to the backside of tree and continues to do so. The tree has **CODOMINANT STEMS** that are prime for breaking off, like its neighboring tree. One of the stems has its own **CODOMINANT STEMS** which only compounds the **RISK** this tree may pose. Top heavy, weak rooted and close to the house make this a **RISK** tree that could deal a severe impact to house and property.

Cankers along trunk

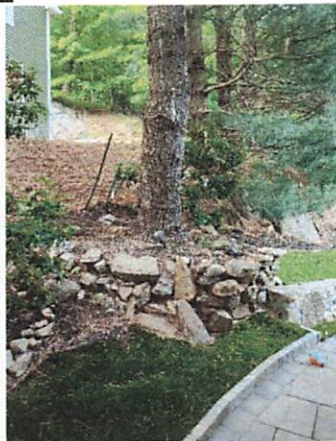
Not much room for root growth

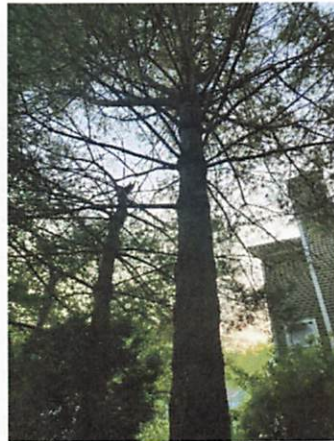
Five codominant stems

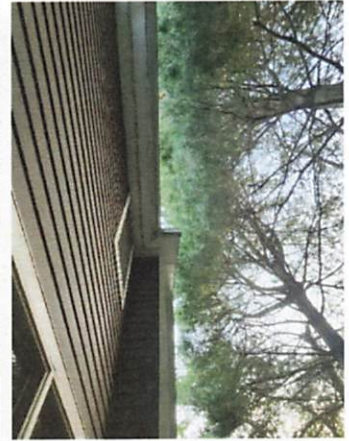
Towering over house

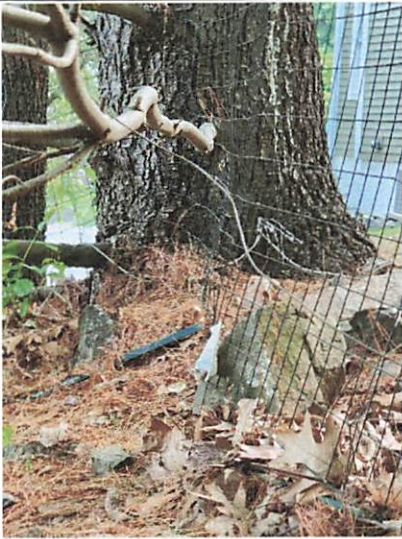
Eastern White Pine (5 thru 7)

These pines have similar issues. These are the only pines in the group that has lateral branches with foliage. These trees have been maintained to keep their foliage intact, but this requires more maintenance and at a higher cost since these trees are a good 40'-50' tall. It's not easy trimming the tops compared to a tree with much less maintenance requirements. All trees are growing on ledge rock and a clay soil slope. The soil erosion has buried the back side of the trees affecting their **CRZ**. All trees have **CODOMINANT STEMS** and are a **RISK**. One is growing through a wire fence and rocks with constant contact with rocks will cause **DECAY** at its base and likely to fail. There are signs of cankers along the trunks, most likely caused by branches breaking off during storms and not healing correctly. These trees have served their objective long ago, but the **RISK** does not outweigh the benefits. It's time to reboot, so I recommend removal of these **RISK** trees. Any one of them that fails will surely damage the pool's vinyl liner, the house and whatever else may be beneath.

Tree growing thru fence and rocks

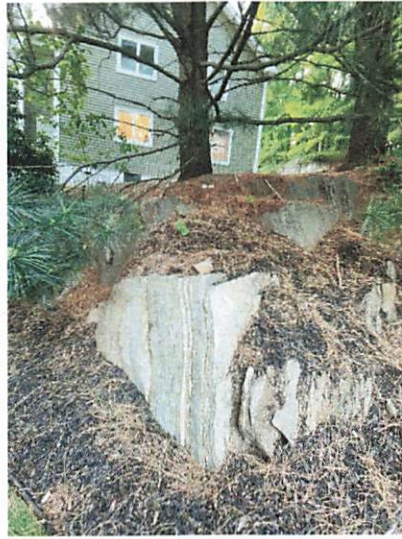
Ledge rock

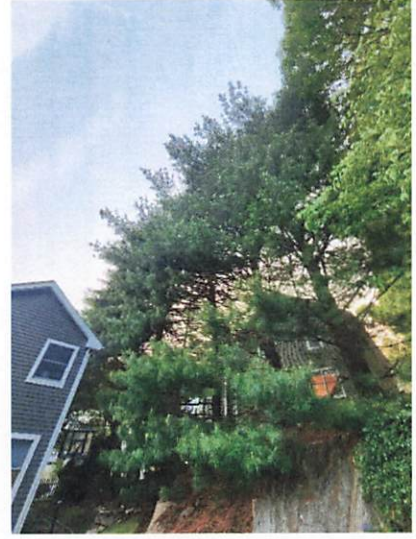
More ledge rock

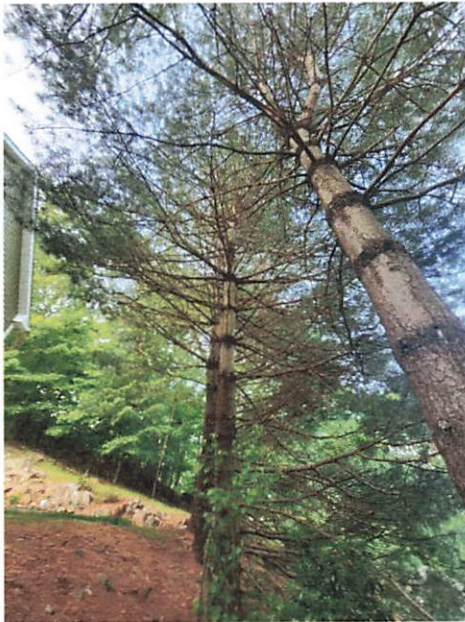
Soil build up over CRZ

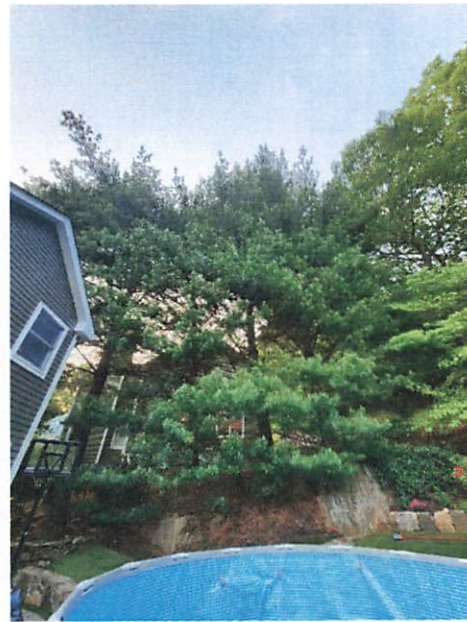
Pool is at risk
