AGENDA ITEM: PUBLIC HEARING FOR REVIEW OF THE APPLICATIO OF 41 CEDAR STREET

CEDAR COMMONS TREE AND SHRUB ASSESSMENT

41-45 Cedar Street

May 8, 2020

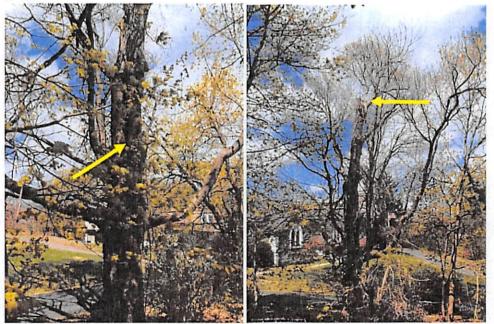
ID #21 is a 32-inch sugar maple tree. It grows approximately three feet from the staked line. The top of tree has been previously broken at approximately 35-40 feet. There is large deadwood in its canopy and large cavity with significant decay from 12-16 feet along its trunk. It does not appear as though the tree has been maintained. The trunk and canopy lean slightly toward the driveway. This tree currently represents an elevated risk to person and property on church property due the level of decay and large deadwood. This tree should be removed prior to construction regardless of whether the project progresses.

Photos taken 4/22/2020 showing ID #21. Note the broken top and large cavity in its trunk (yellow arrows).

The large sugar maple (#21) is the only tree species on church property that is not invasive. It has significant structural concerns and is in poor condition. If the tree is not removed prior to construction, excavation will remove a large portion of its critical root zone and increase its likelihood of failure.

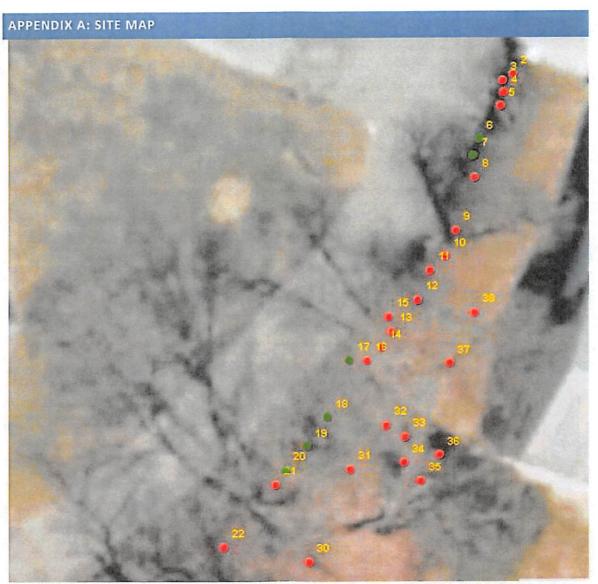
Screen shot from ArcGIS Online of the tree inventory map. Red icons are tree/shrubs that will need to be removed; green icons are shrubs that can be preserved during construction.
