Tree Evaluation Report

Winiarski Residence
63 Livingston Avenue
Dobbs Ferry, NY 10522

October 5, 2022

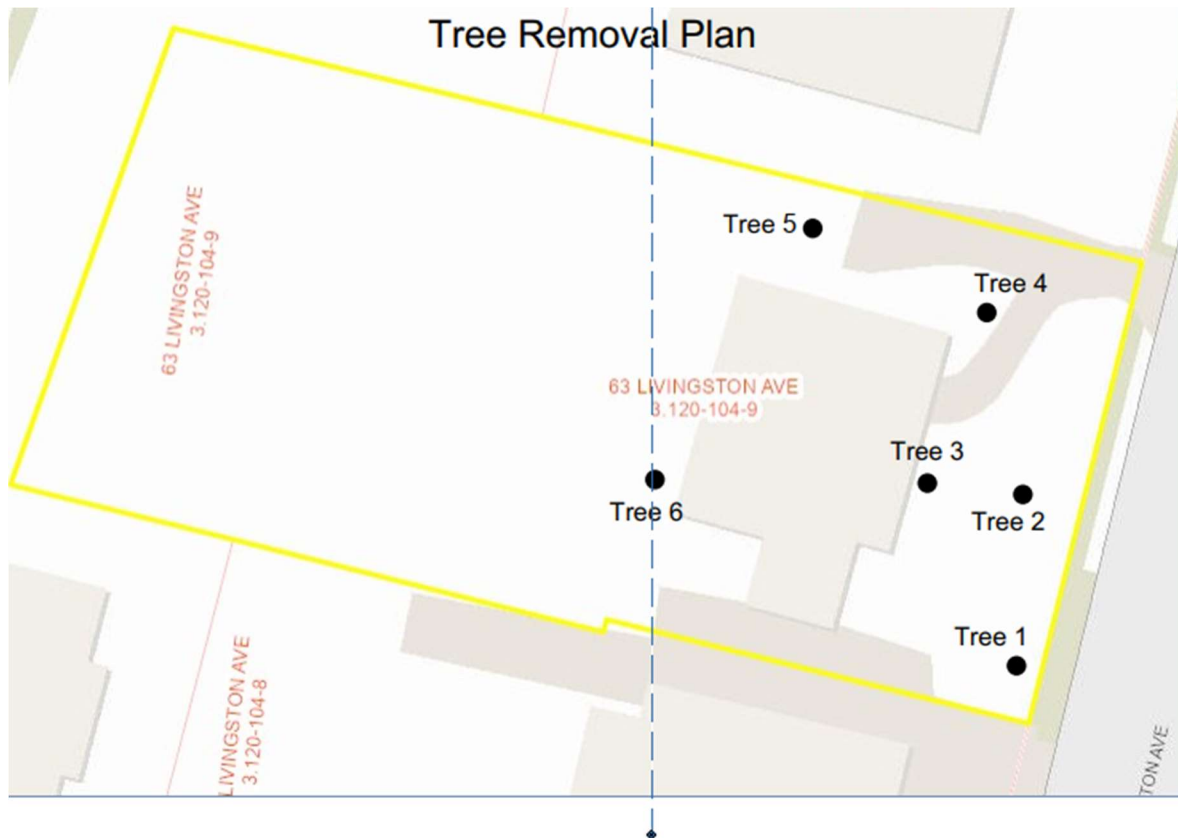
Tree 1 - Red Maple
Tree 2 - Norway Spruce
Tree 3 - Hemlock
Tree 4 - Norway Spruce
Tree 5 - Norway Maple
Tree 6 - Red Maple
