## **Lombardo's Restaurant** **ADA Memorandum**

This Memorandum is to address concerns that the structure proposed at Lombardo's Restaurant to enhance the exterior dining area on the terrace located at 10 Hamilton Street will interfere with ADA compliant access to the Urgent Care facility located immediately to the south of the subject restaurant.

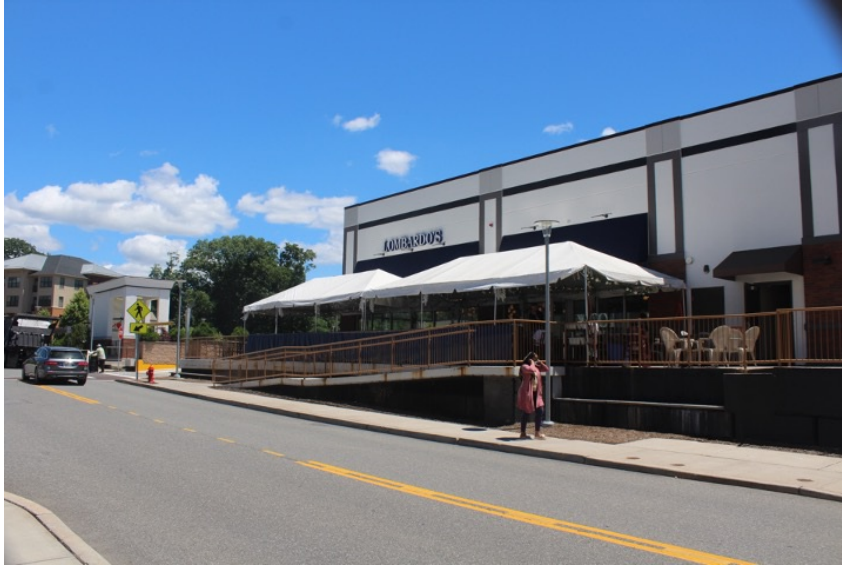
Photo 1

View looking northeast from Hamilton Street towards the sidewalk in the public right-of-way in front of the Lombardo terrace behind the ADA compliant ramp that accesses the Urgent Care terrace.

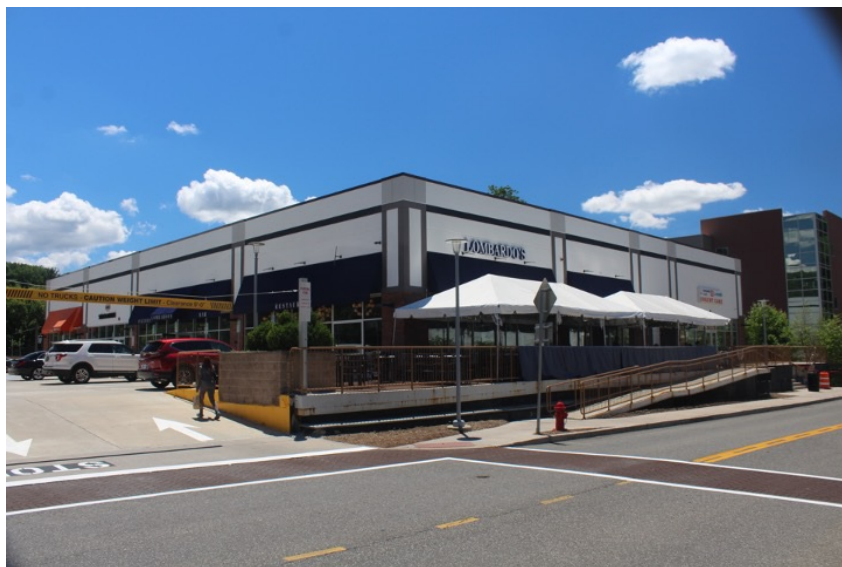
Photo 2

View looking southeast from Hamilton Street towards the sidewalk in the public right-of-way in front of the Lombardo terrace behind the ADA compliant ramp that accesses the Urgent Care terrace.

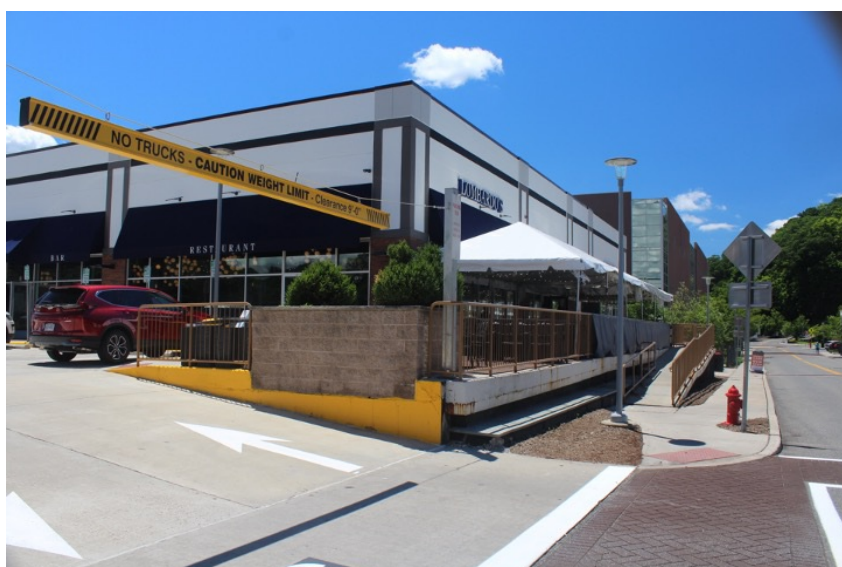
Photo 3

View looking south on Hamilton Street down the sidewalk in the public right-of-way with the ADA compliant ramp that accesses the Urgent Care terrace to the left. The railing and tents are in the area of the exterior dining area at Lombardo's Restaurant.

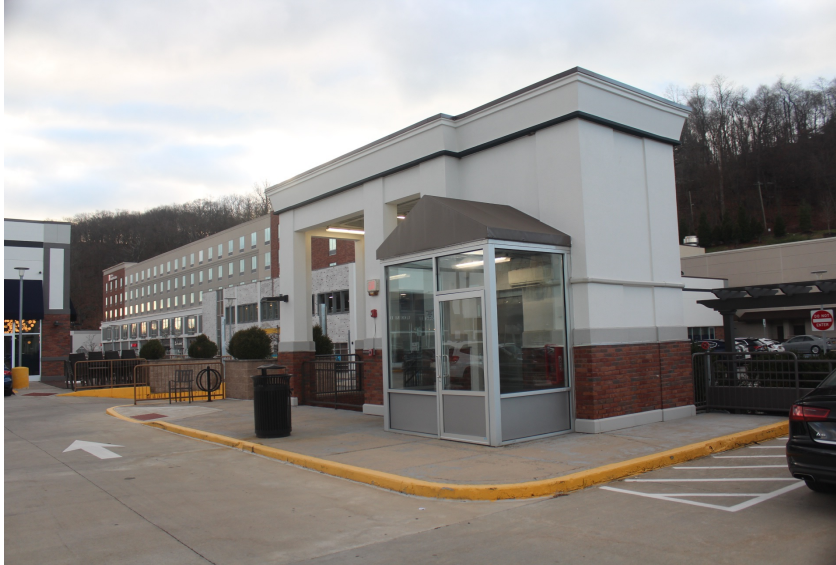
Photo 4

View looking southwest from the parking lot to the north of Lombardo's Restaurant looking at the structure housing the elevator and ADA compliant ramp that connects the parking lot to the ADA compliant sidewalk in the public right-of-way.

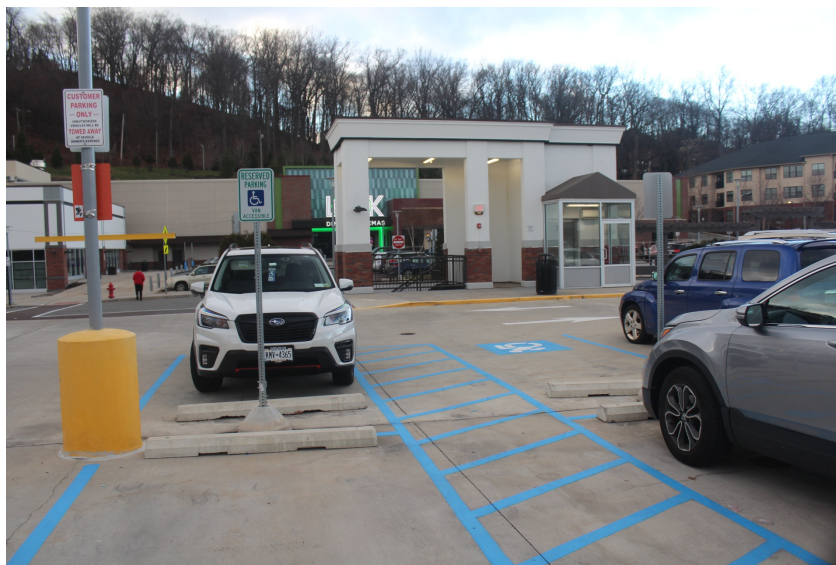
Photo 5

View west towards the structure housing the elevator and ADA compliant ramp with the ADA compliant handicapped parking spaces in the foreground.

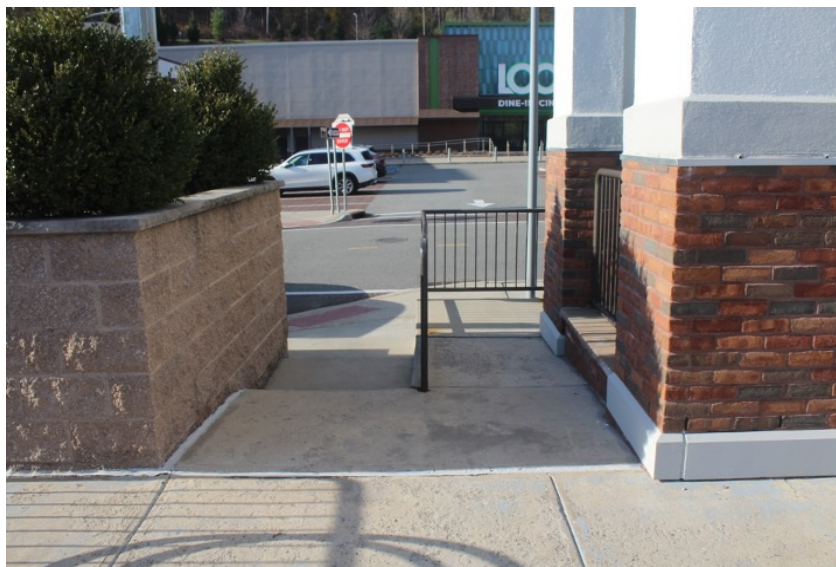
Photo 6

View of the ADA compliant ramp that connects the parking lot north of Lombardo's Restaurant to the ADA complaint sidewalk located in the dedicated right-of-way adjacent to site.

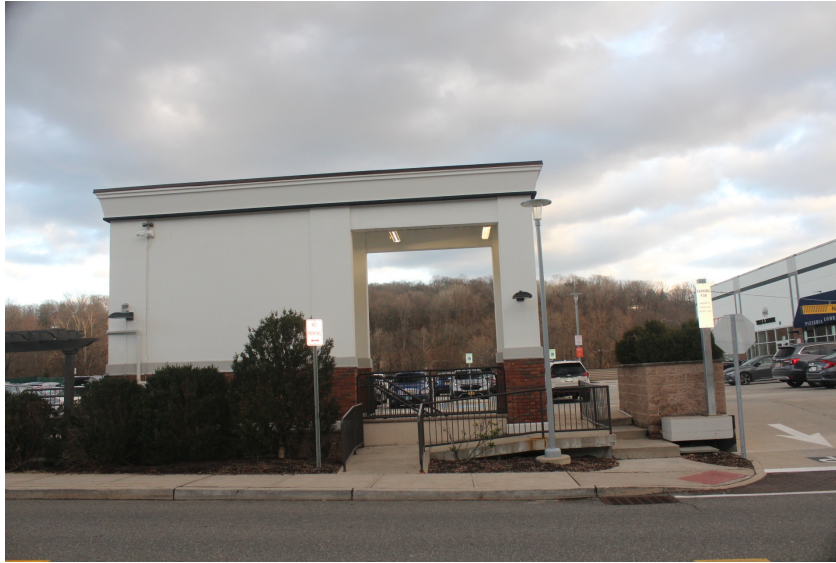
Photo 7

View east towards the structure housing the elevator and ADA compliant ramp that connects the parking lot on the Lombardo's Restaurant site to the ADA complaint sidewalk in the public right-of-way immediately adjacent to the site.

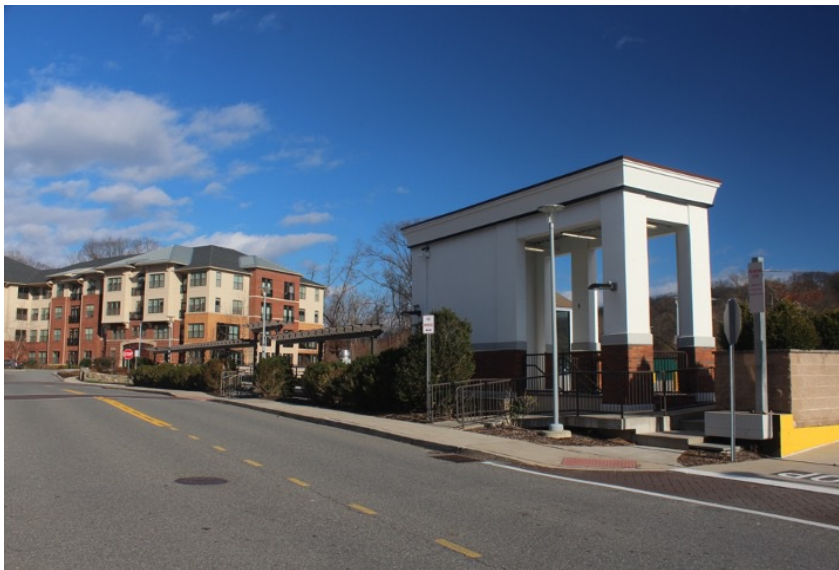
Photo 8

View looking northeast towards the structure housing the elevator and ADA compliant ramp that connects the parking lot to the ADA complaint sidewalk in the right-of-way adjacent to the site.

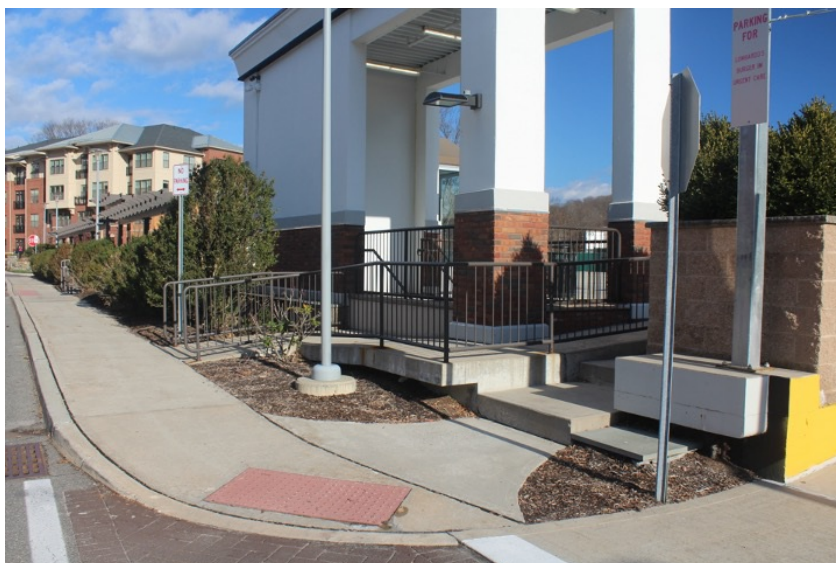
Photo 9

View looking northeast towards the structure housing the elevator and ADA compliant ramp that connects the parking lot to the ADA complaint sidewalk in the right-of-way adjacent to the site.

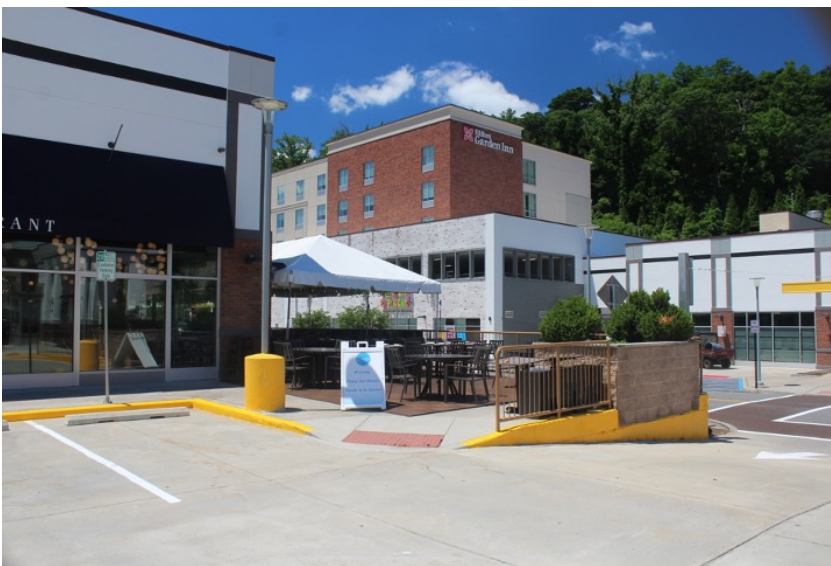
Photo 11

View looking southwest from the parking lot at the corner of Lombardo's towards the exterior dining area on the terrace facing the street.

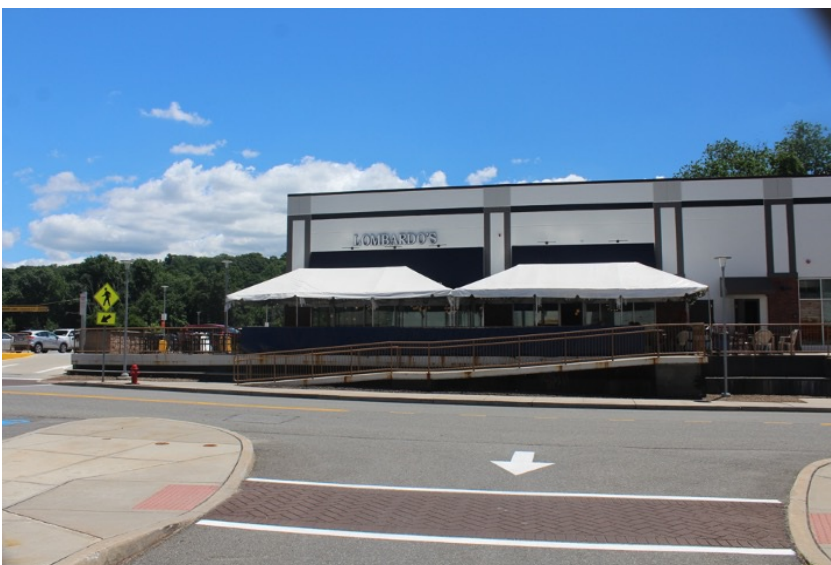
Photo 12

View from the other side of Hamilton Street looking east towards the restaurant and exterior dining area on the Lombardo's terrace with the ADA compliant ramp and sidewalk in the dedicated public right-of-way connecting to the Urgent Care terrace and entry.
